# **AIRCRAFT ACCIDENT REPORT**

**CONTROLLED FLIGHT INTO TERRAIN  
AIR CHINA INTERNATIONAL FLIGHT 129  
B767-200ER, B2552  
MOUNTAIN DOTDAE, GIMHAE  
APRIL 15, 2002**

**KOREA MINISTRY OF CONSTRUCTION AND TRANSPORTATION  
KOREA AVIATION-ACCIDENT INVESTIGATION BOARD**

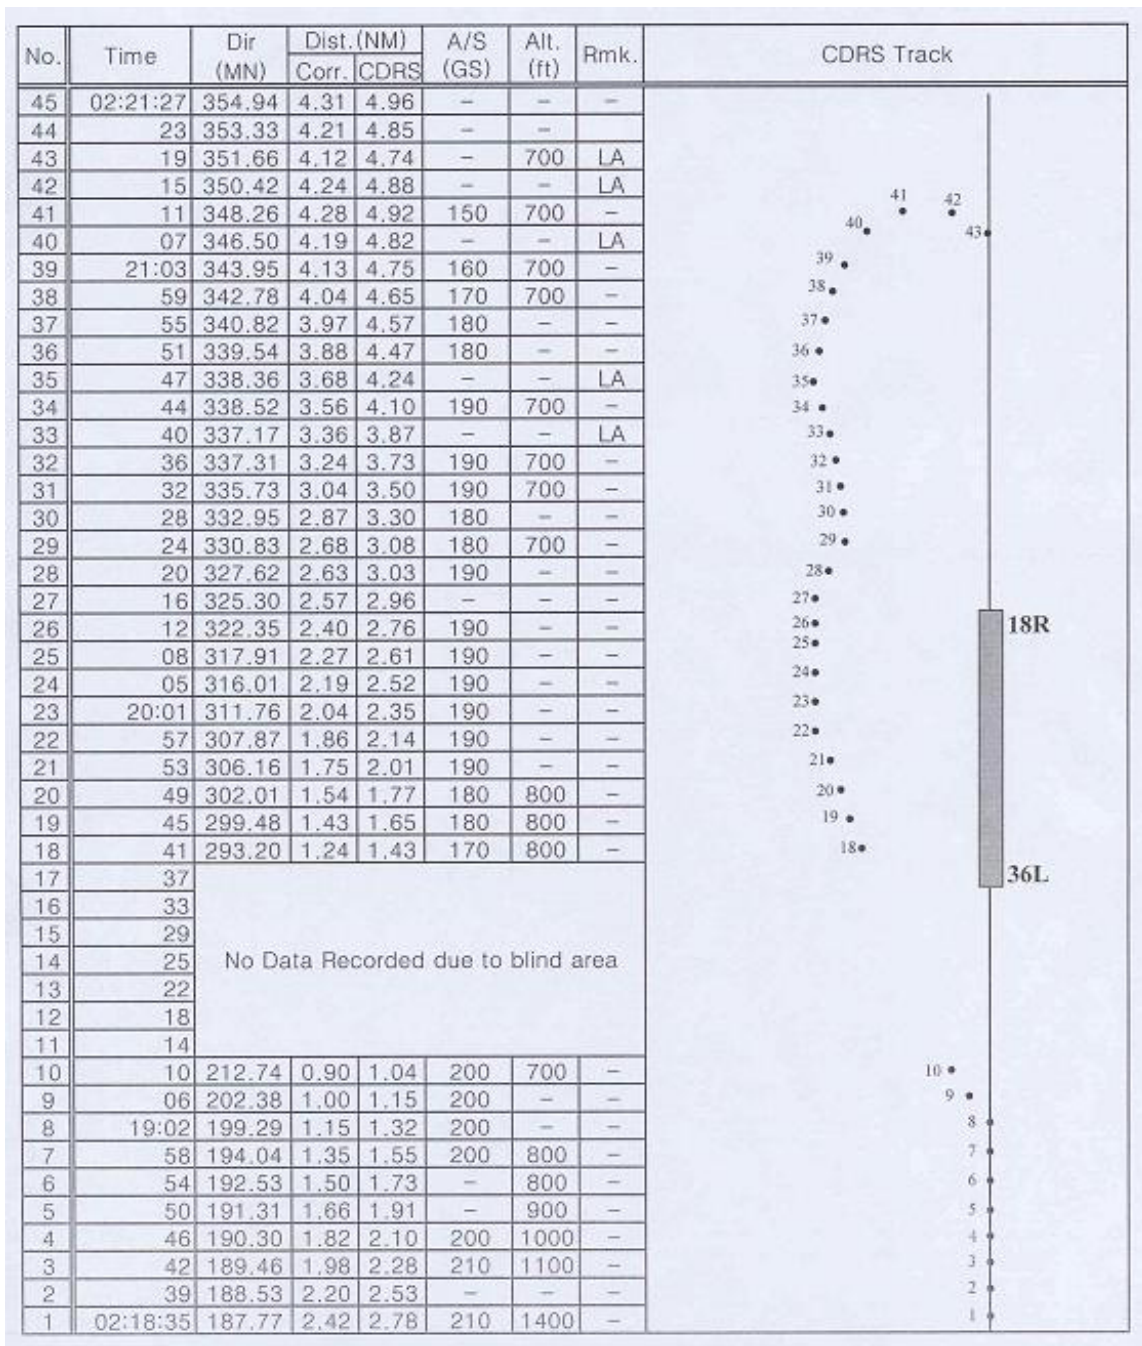
Figure 1-6 CDRS Data

\* Approximately 200 ~ 1,100 meters of difference existed from the final approach course to runway 36L to the crash point in the flight track on the drawing based on the CDRS data scaled one to 50,000, thus the CDRS data (distance) was multiplied by an invariable number 0.868976, and the revised the distance was calculated for the correction on the drawing. The flight track was composed on the basis of the revised data.

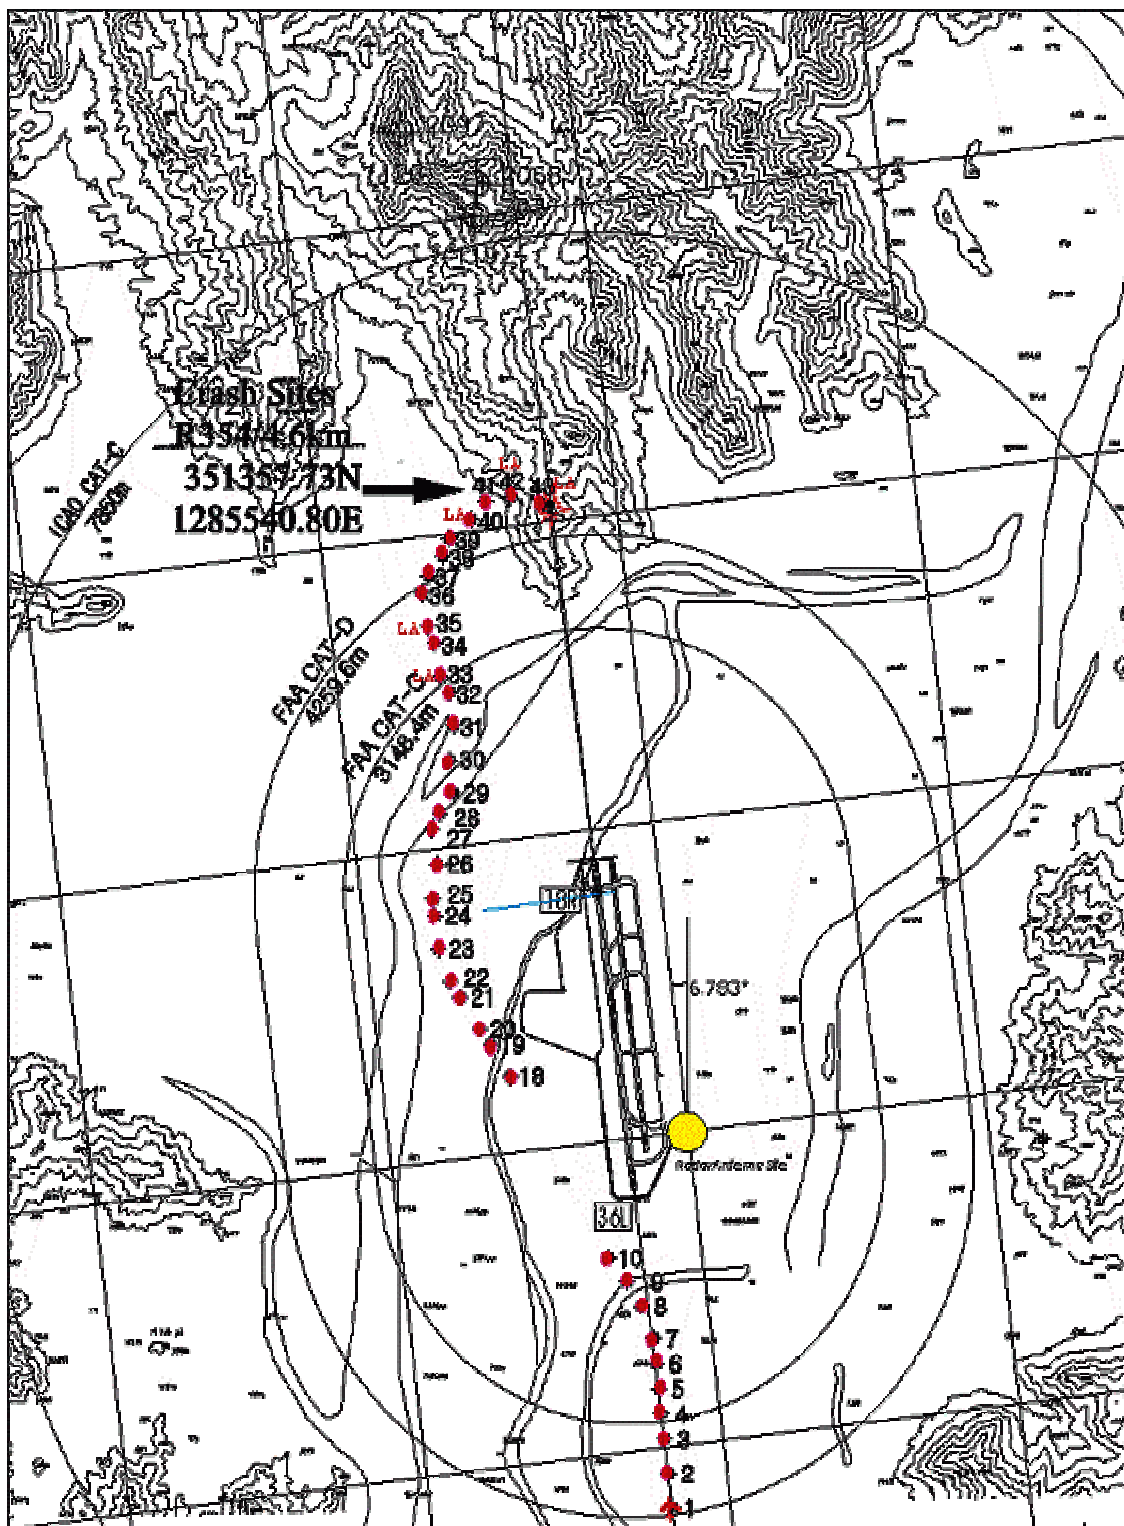
Figure 1-7 Circling Approach Radar Track of Flight 129 and Circling Approach Area

According to the statement<sup>57</sup> of the captain of flight 129, he observed the runway lights on the final approach course to runway 36L, however, he saw neither the runway lights on the downwind leg nor circling guidance lights during the circling approach. According to the record of the automatic aeronautical light switching system, and the testimony of the Gimhae tower duty chief in the public hearing, the runway, approach and circling guidance lights<sup>58</sup> of runway 18R were on at the time of the accident.

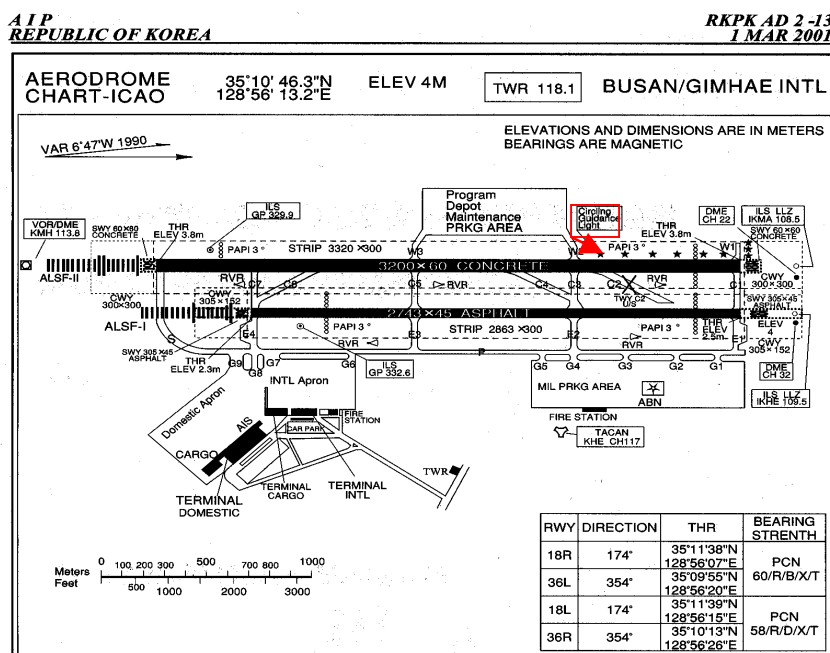
Figure 1-8 Circling Guidance Lights at Gimhae Airport

The automatic light switching and recording systems, used to calculate lighting fees, were installed in the lighting control room. The lighting times are automatically calculated by the clock installed in the system computer. The investigation revealed that the clock had been running about 19 minutes “fast,” and the clock was reset correctly by an engineer about 20:30 on April 18, 2002.

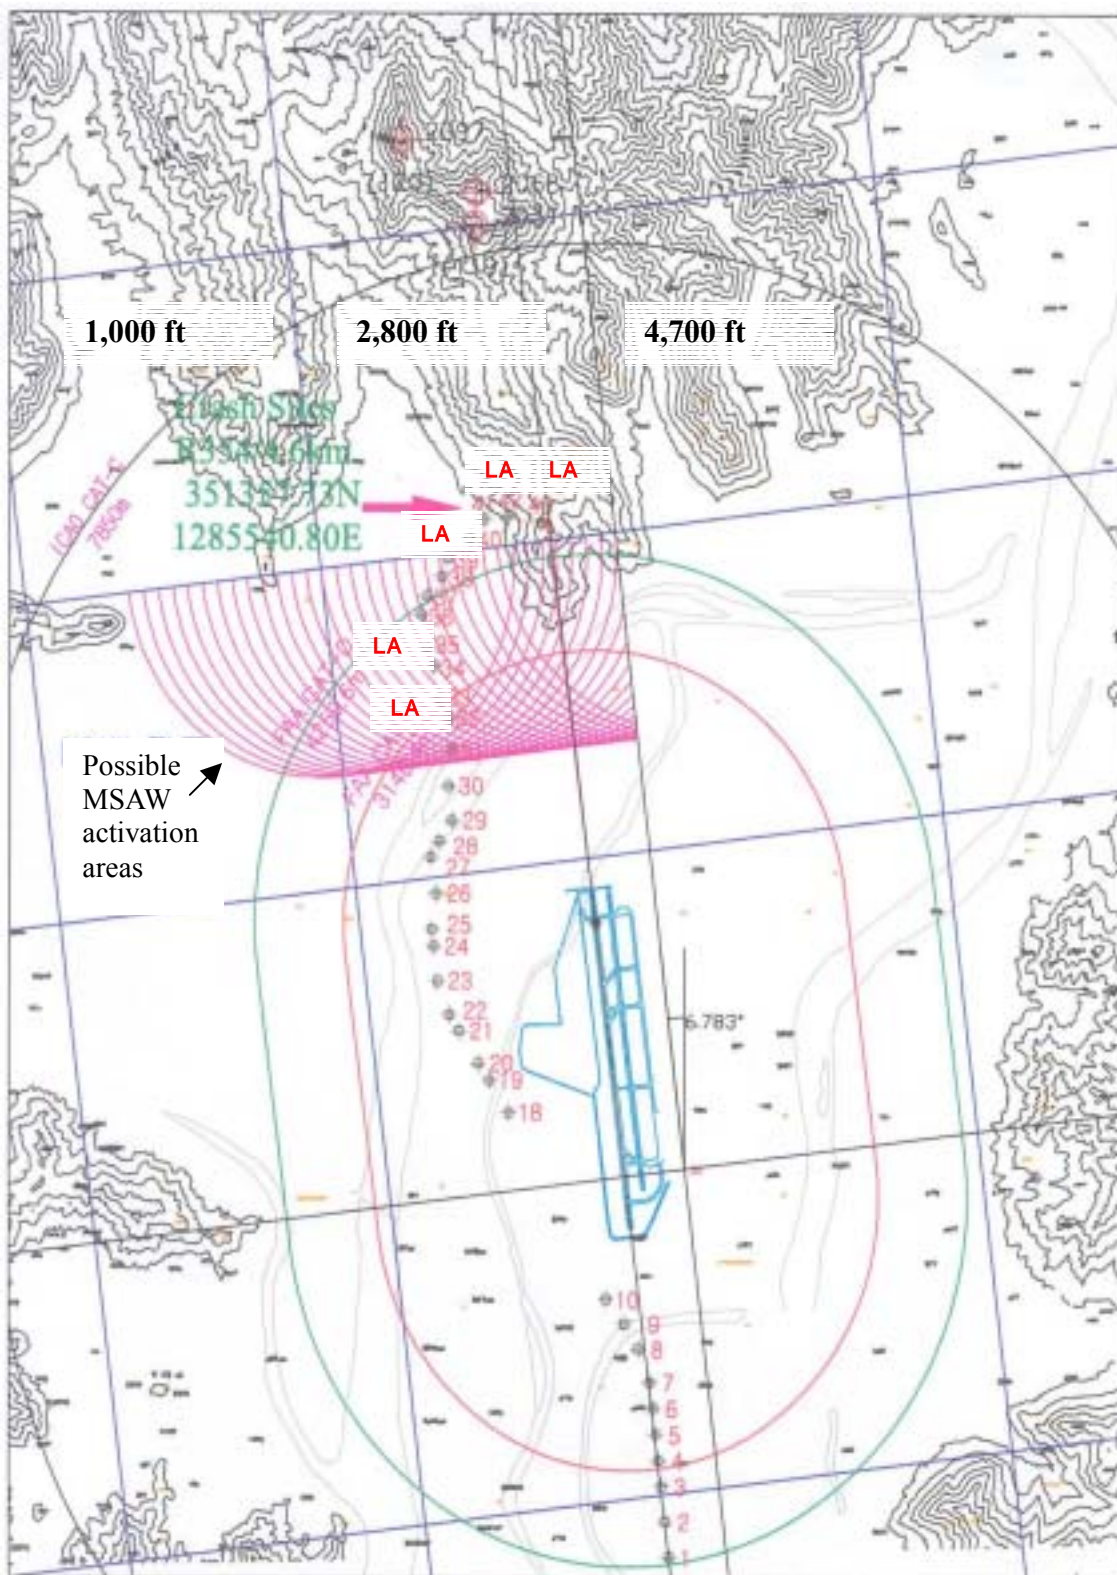
Figure 1-9 Possible MSAW Activation Areas and Circling Approach Area

The MSAW was programmed according to the standards described in the Airforce manual. The approach control area was divided into 2 NM square bins, for a total of 4,900 bins, where the minimum safe altitude of each bin was programmed with 700 ft above the highest obstacle. As shown on Figure 1-9, the minimum safe altitude of the airport's northern bin where Mt. Shinuh<sup>60</sup> is positioned was programmed to 2,800 ft in consideration of the height of that mountain (2,076 ft), and it was set to 1,000 ft for the west bin, and 4,700 ft for the east bin respectively.

<sup>61</sup> The areas where the predictive warning can be activated in accordance with flight distance by the aircraft heading and speed by means of MSAW predictive warning function (in the case of flight 129, the predictive warning was possible in front of about 1.4 NM, applying 170 kt of ground speed).

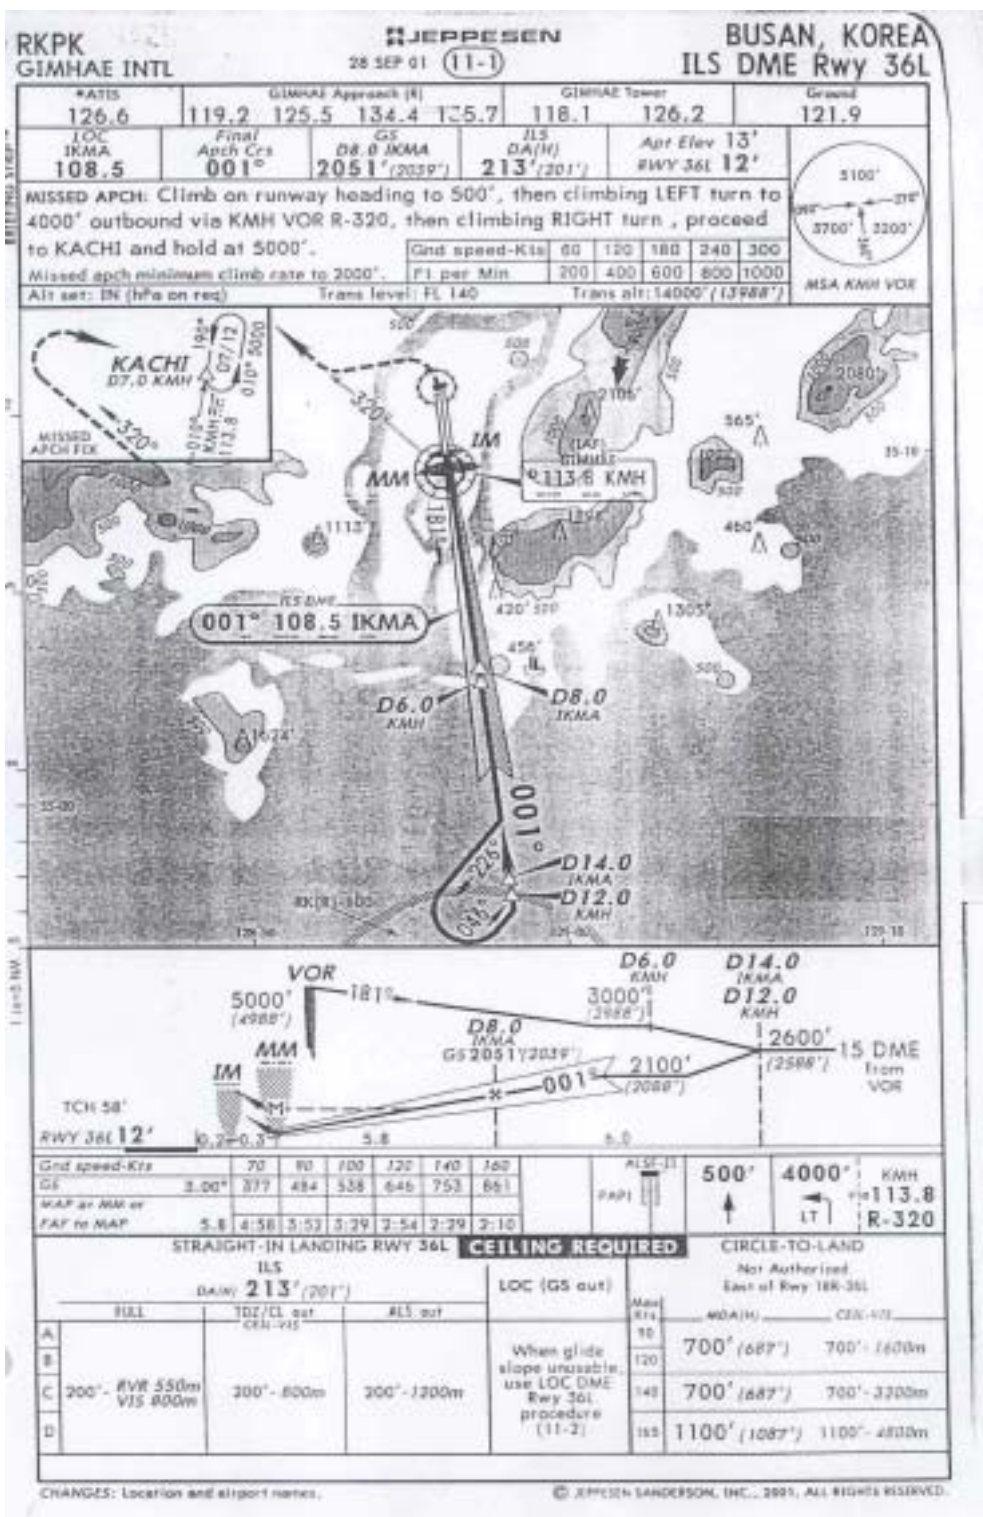
Figure 1-11A RWY 36L Instrument Approach Chart (Issued date: SEP 25, 01)

The instrument approach chart used<sup>66</sup> by the flight crew of flight 129 as shown on Figure 1-11A (ILS DME Rwy 36L, effective SEP 25, 01), displayed the plan view with contour lines and different shades of color to show heights of the terrain, and obstacle symbols marked with the elevations. The enlarged depiction of the missed approach holding precluded showing the obstacles to the north of the circling approach area. The Jeppesen chart of the Busan, Korea ILS DME or LOC DME Rwy 36L published Oct 25, 2002 was revised according to the amended ROK AIP. Jeppesen took the opportunity in this revision to improve the plan view depiction by changing the plan view scale to include a larger area, including the terrain and obstacles in the vicinity of the accident as shown on Figure 1-11B.

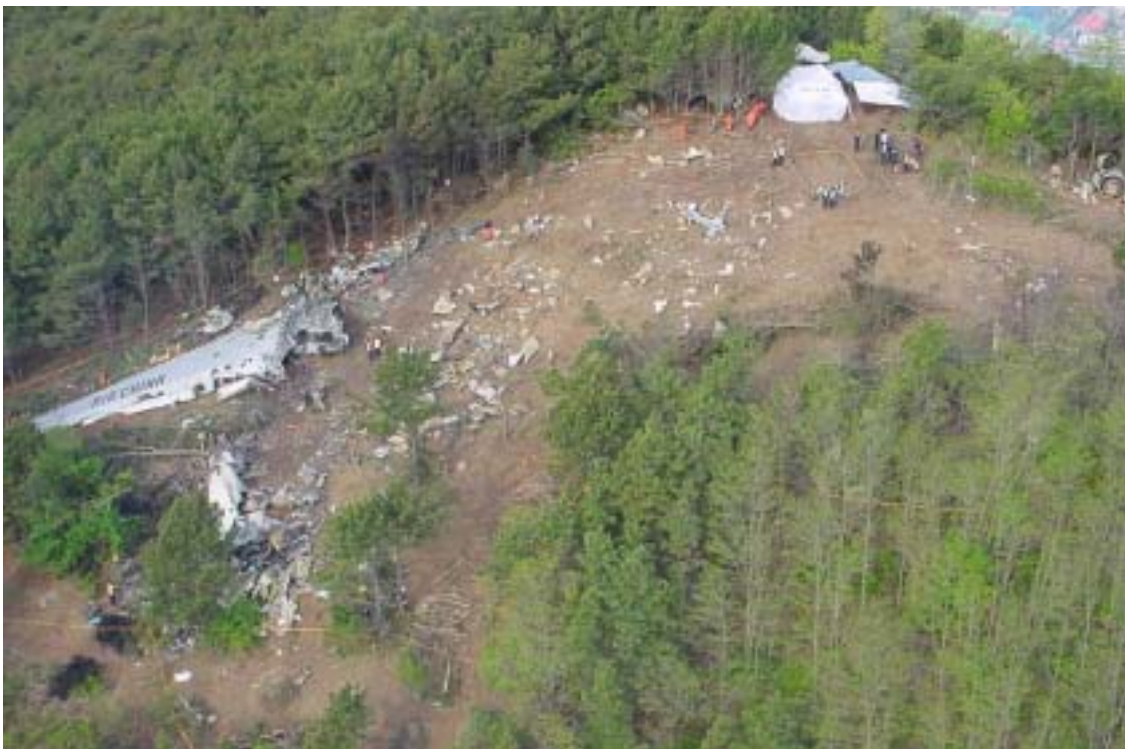
Figure 1-14 Photograph of the Accident Site

The investigation results on ground markings and the wreckage distribution pattern<sup>82</sup> showed the initial contact with terrain of an elevation of 204m, where the right wing struck trees. As shown on the Figures 1-13 and 1-14, the wreckage was scattered in an area about 200 m long and 100 m wide.
